State Fire Marshal's Alert

February 22, 2006

University Campus Liquid Nitrogen Cylinder Explosion

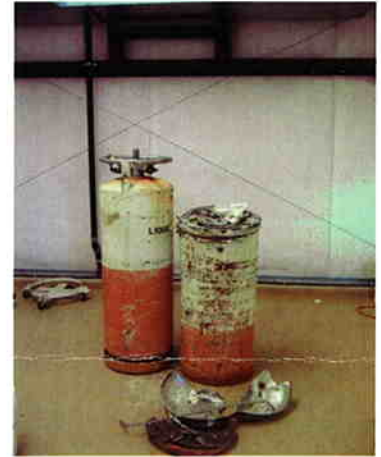
Figure 1 -Effect of Explosion on Dewar Cylinder Compared to unaffected cylinder

The State Fire Marshal's Office, in cooperation with the university's environmental health & safety office, conducted an investigation that included an assessment of the building damage and reconstruction of the events leading to the explosion. The resulting examination revealed catastrophic failure of the cylinder. The failure permitted rapid expansion of the nitrogen gas, blowing out the bottom of the tank and propelling the cylinder upwards.

The examination revealed that the cylinder's pressure release valve and rupture disc had been replaced by two brass plugs. Without these two features in place, the cylinder's rupture-prevention function became compromised. During the investigation, lab students related that the bottom portion of the cylinder had been frosting for approximately twelve to eighteen months, suggesting to them that the cylinder was "leaking". It is speculated that

the tank was relieving normal excessive pressure through an old leaking gasket on the top of the tank (the actual pressure-relief function had been plugged). Approximately twelve hours prior to the explosion, one of the students replaced the leaking gasket and refilled the cylinder. As the old gasket that helped relieve internal pressure had been replaced, the now full cylinder was completely sealed. The cylinder ruptured when its internal pressure rose above 1,000 psi.

The catastrophic failure of the nitrogen cylinder was a direct result of the removal and subsequent plugging of the internal tank pressure relief devices. The cylinder was modified by inexperienced and unidentified person(s) resulting in the eventual failure of the cylinder. It could not be determined when the modifications took place.

- Repair, replace or remove from service leaking, damaged, or corroded compressed gas cylinders or systems.
- Implement and sustain a preventative maintenance program for all compressed gas cylinders and systems. A preventative maintenance program shall include periodic inspection of all cryogenic fluid storage systems and replacement of pressure relief valves every five years, ensuring the valve is set as required by the tank design. A record of the inspection should be prepared and provided to the user or the authority having jurisdiction upon request.

- Ensure that an individual trained in tank usage be in attendance at all times cryogenic fluid is transferred from one container to another.
- All service, repair, modification, or removal of valves, pressure-relief devices, or other container appurtenances shall be performed in accordance with National Fire Protection Association (NFPA) Standard 55 and the Compressed Gas Association (CGA) guidelines (<http://www.cganet.com/Publication.asp?mode=c>).

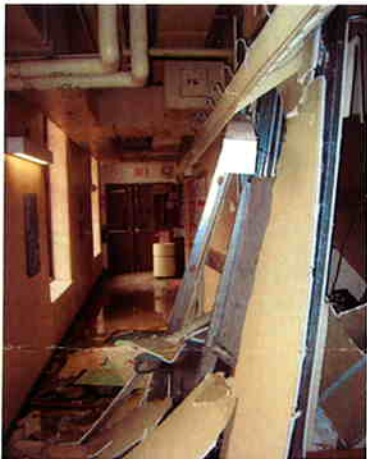
Figure 2 - Hallway Outside Laboratory Showing Explosion Damage

At approximately 3:00 a.m. on Thursday, January 12, 2006, an explosion occurred in a state university chemistry building laboratory, causing substantial building damage. The explosion resulted from a rupture in a liquid nitrogen (Dewar) cylinder. The cylinder was originally constructed and tested in December 1980.

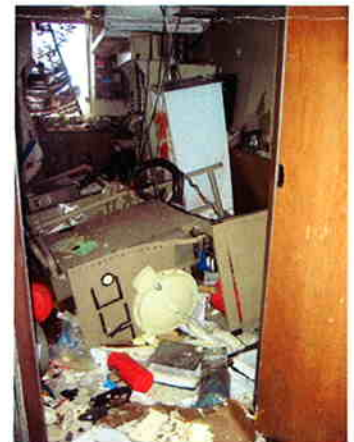
Figure 3 - Inside the Laboratory after Explosion
